April 3, 2017

On March 14, 2017 and March 28, 2017, the Martin County Sheriff's Office conducted a lighting survey of the Golden Gate Community. Overall, the existing lighting is very poor. Many of the areas had such poor lighting the visibility was at zero. In addition to areas with no light fixtures some were covered by tree limbs, the light was blocked by trees and bushes or the light fixture had bulbs that were burnt out. We measured the lighting using a light meter measuring the effectiveness of the light in foot candles.

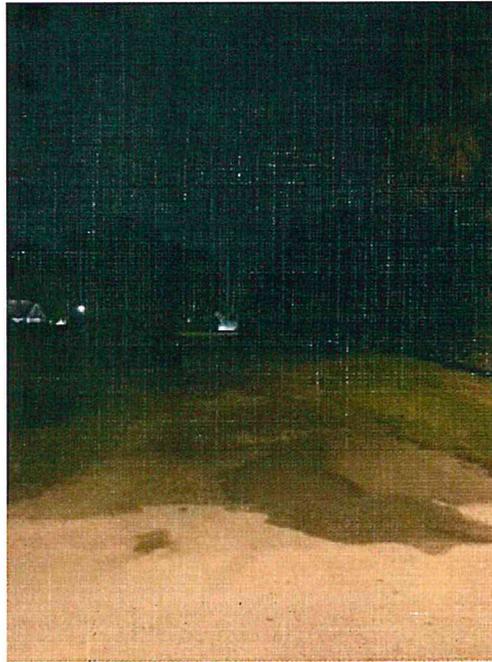
- Alley way near 2951 Hawthorne was noted as 1.47 fc. Once you walked on to the pathway visibility was zero. Potential ambush point.

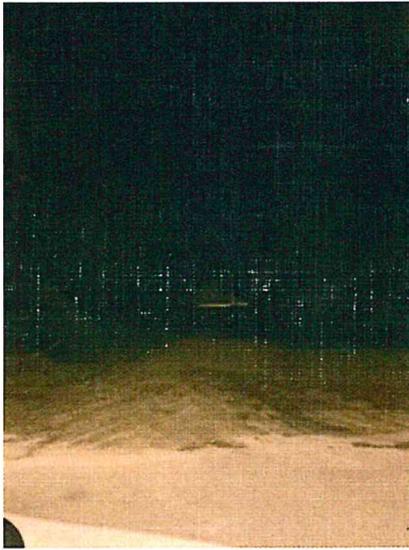
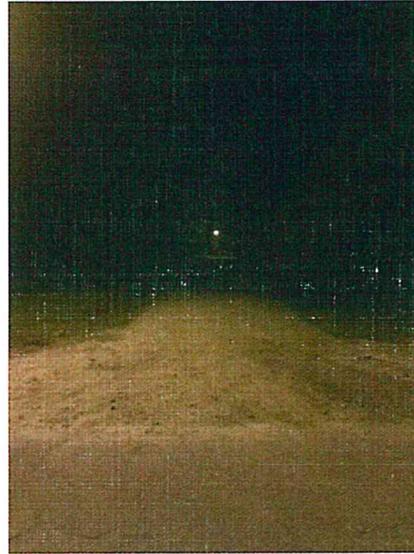
- Poor lighting and area of concern on Durant Avenue. Once a person walks on this cut through, their visibility is zero.

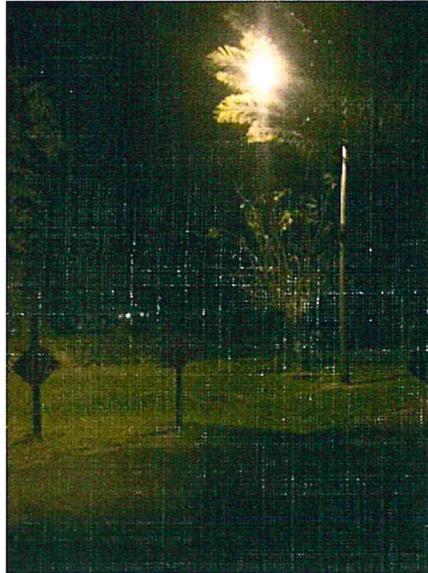
- At the end of Fairmont, lighting is being blocked by a palm tree. It is crucial that greenery be maintained in order for lighting to be maximized.

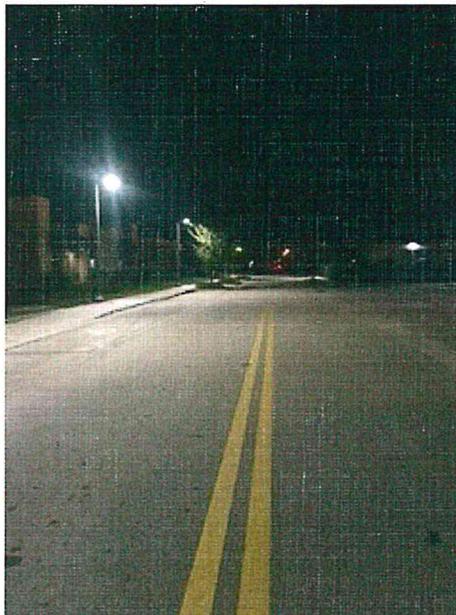
- This picture was taken at the intersection of Delmar and Dixie. Here the lighting is sufficient and measured at 5.9 fc.

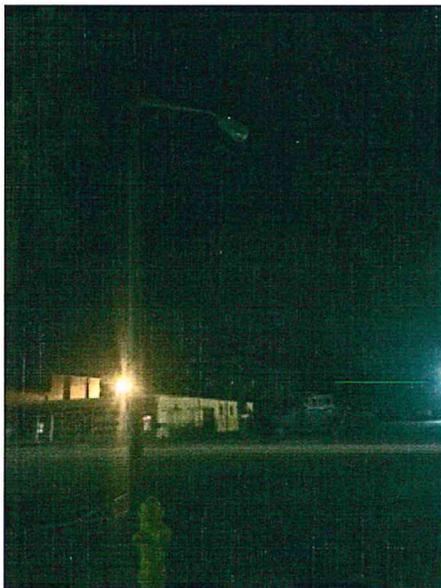
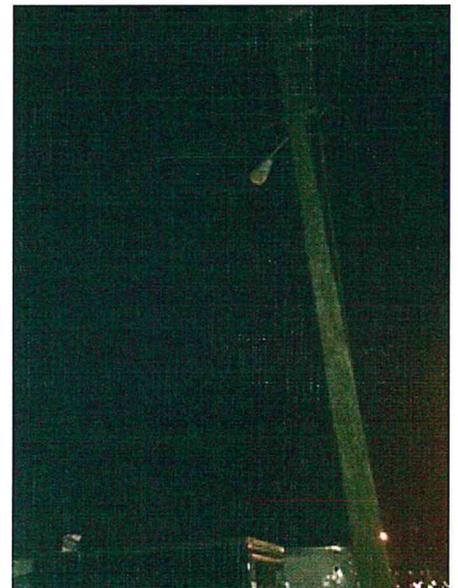
- All three lights in the pictures above are out where they could be providing additional light to the area.
