MARTIN COUNTY, FLORIDA
BANYAN BAY
AMENDED
PRESERVE AREA MANAGEMENT PLAN

Banyan Bay Phase 3

EW Consultants, Inc.

ENVIRONMENTAL ASSESSMENT AND LISTED SPECIES REPORT

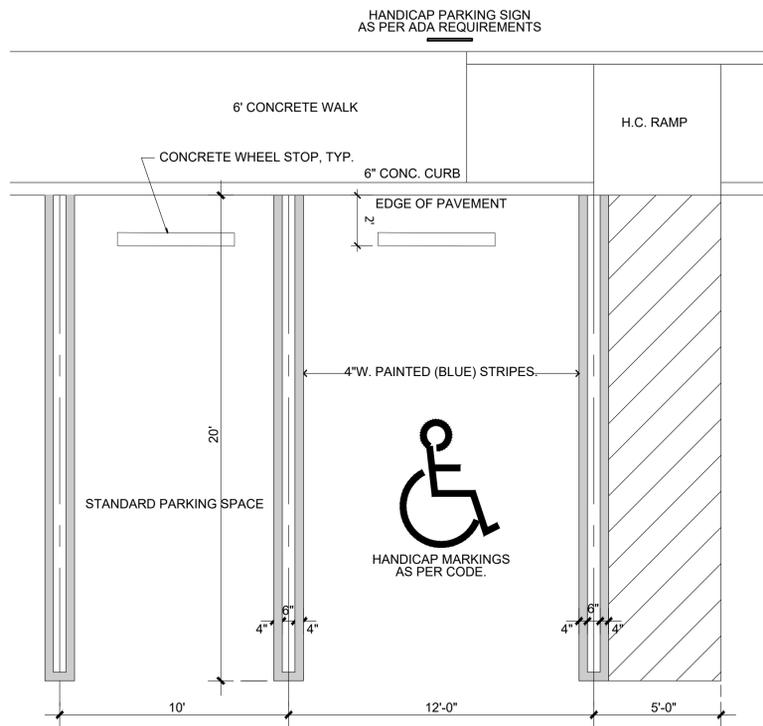
STANDARD & HANDICAP PARKING LAYOUT
N.T.S.

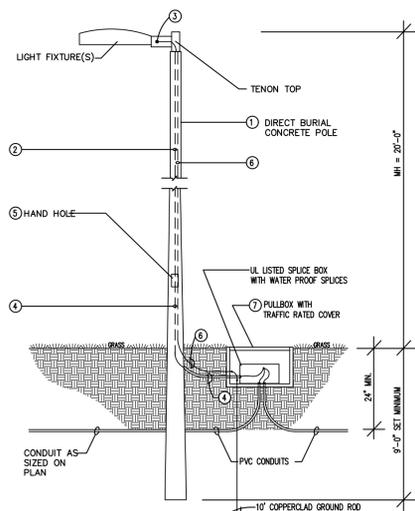
STANDARD LIGHTING POLE DETAIL

CONCRETE LIGHT POLE DETAIL
TO BE USED ON ALL PARKING LOT LIGHTING (20' MOUNTING HEIGHT)
N.T.S.

- (8) MUCK: IF SOFT SOILS ARE FOUND ON THE PROPERTY, THIS POLE DESIGN WILL BE MODIFIED TO ACCOMMODATE. NOTIFY ENGINEER IMMEDIATELY.
- (9) SITE CONDITIONS: IF SITE CONDITIONS ARE DISCOVERED WHICH REQUIRE ANY POLE (S) TO BE MOVED OVER 4 FEET, NOTIFY THE ENGINEER IMMEDIATELY.

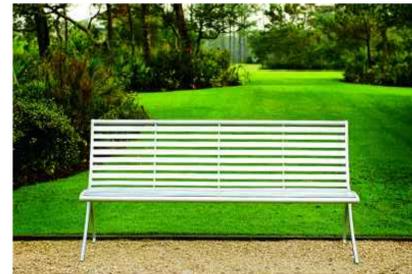
"PARC VUE" BENCH BY LANDSCAPEFORMS (6' BENCH)
COLOR: BRONZE
BENCH DETAIL
N.T.S.

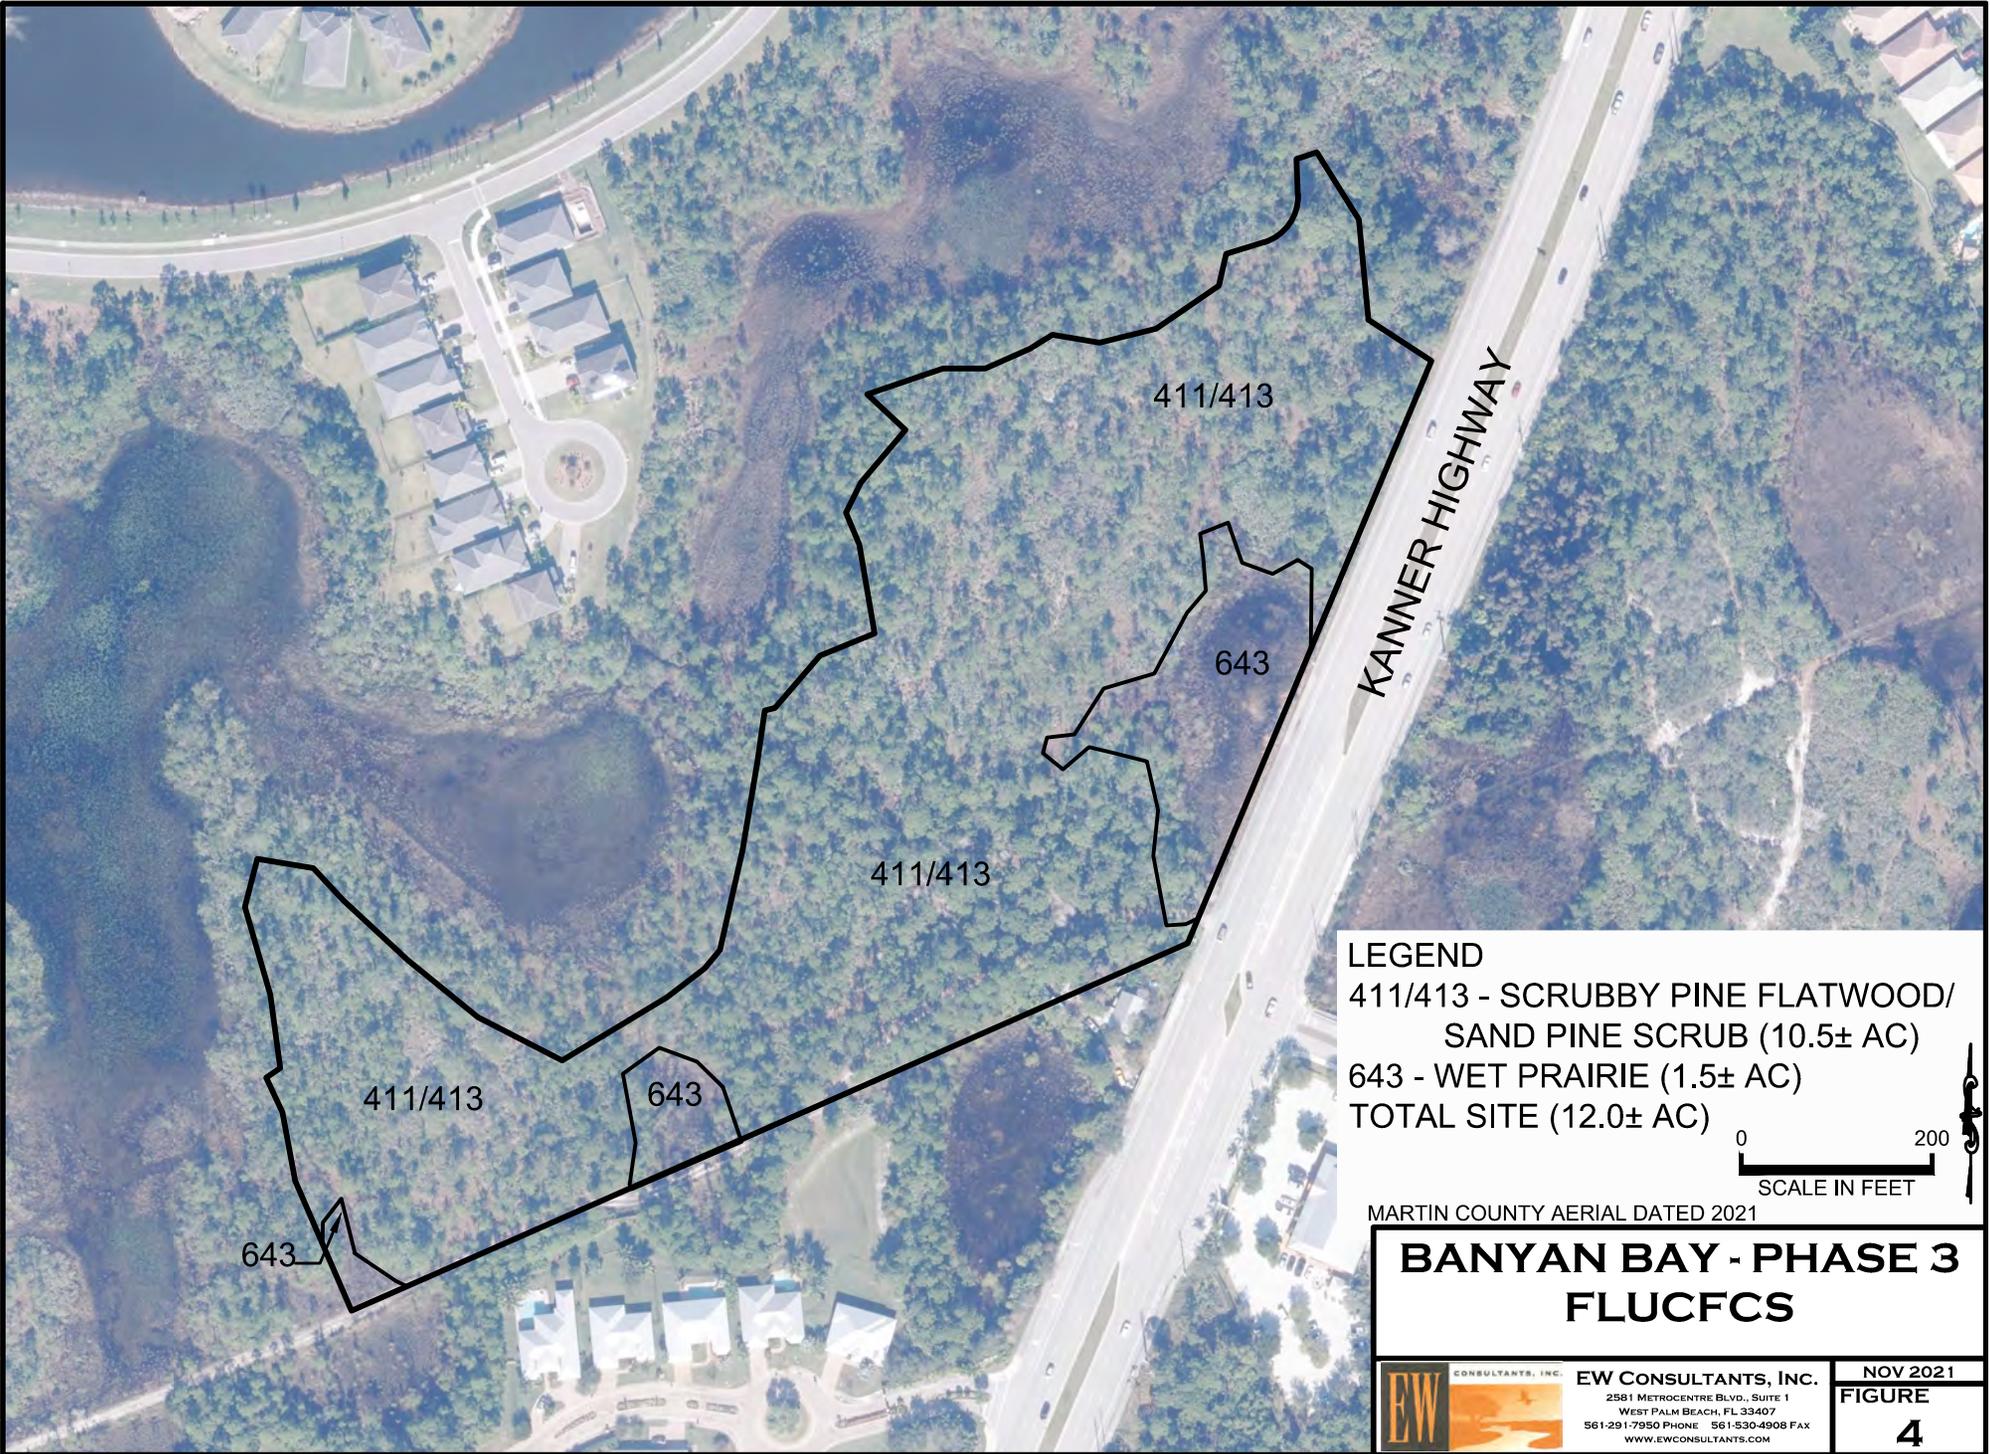
LEGEND

411/413 - SCRUBBY PINE FLATWOOD/
SAND PINE SCRUB (10.5± AC)

2.3 Habitats – A summary of the vegetative communities which currently exist on the subject site can be found in the EA. Vegetative community classifications were mapped based on the Florida Land Use, Cover and Forms Classification System (FLUCCS) developed by the Florida Department of Transportation.

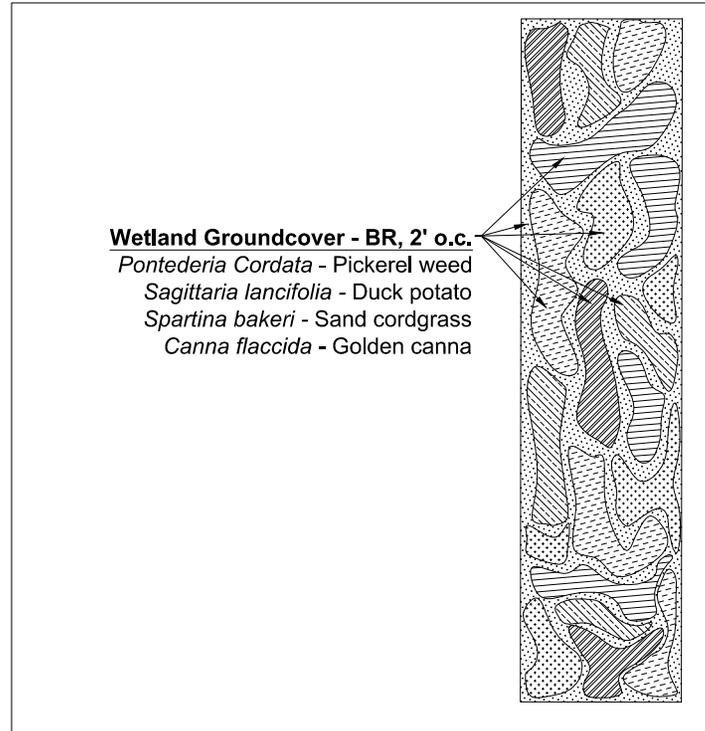
TYPICAL WETLAND RESTORATION
PLANTING PLAN

includes details for restoration of the southern access road that currently exists in wetland and buffer areas. Graphics depicting the detail of the impact areas as well as a planting plan for the restoration of these are included in the Appendix of this PAMP.

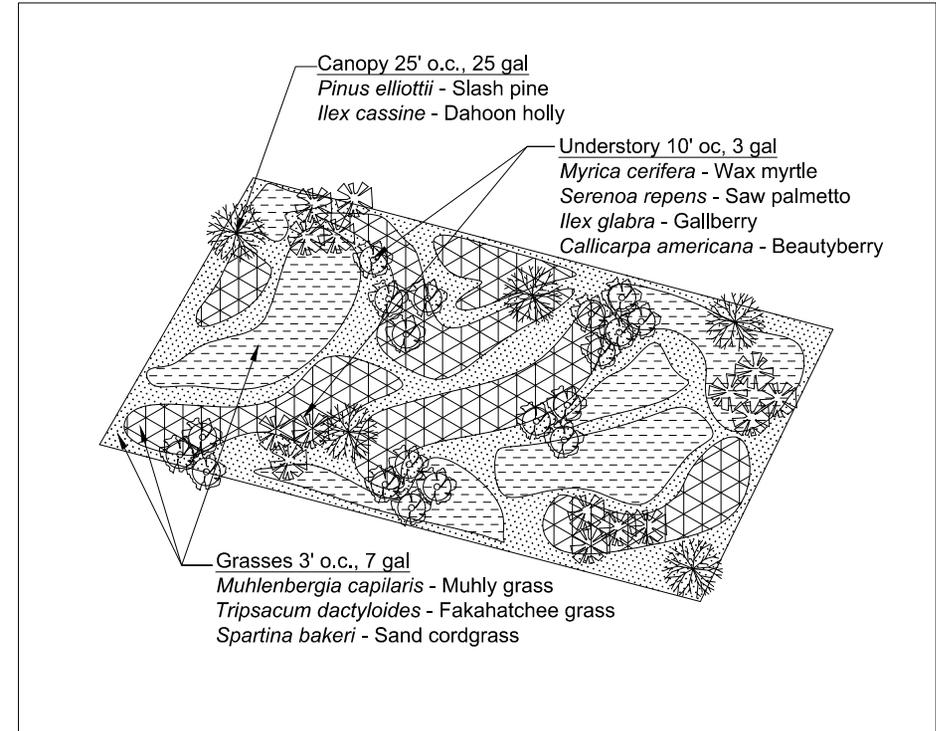
TYPICAL UPLAND BUFFER RESTORATION
PLANTING PLAN

NOTE: PLANTS TO BE INSTALLED AS TO MIMIC NATURAL OCCURENCE.
MATERIAL MAY BE SUBSTITUTED WITH NATIVE LIKE MATERIAL.

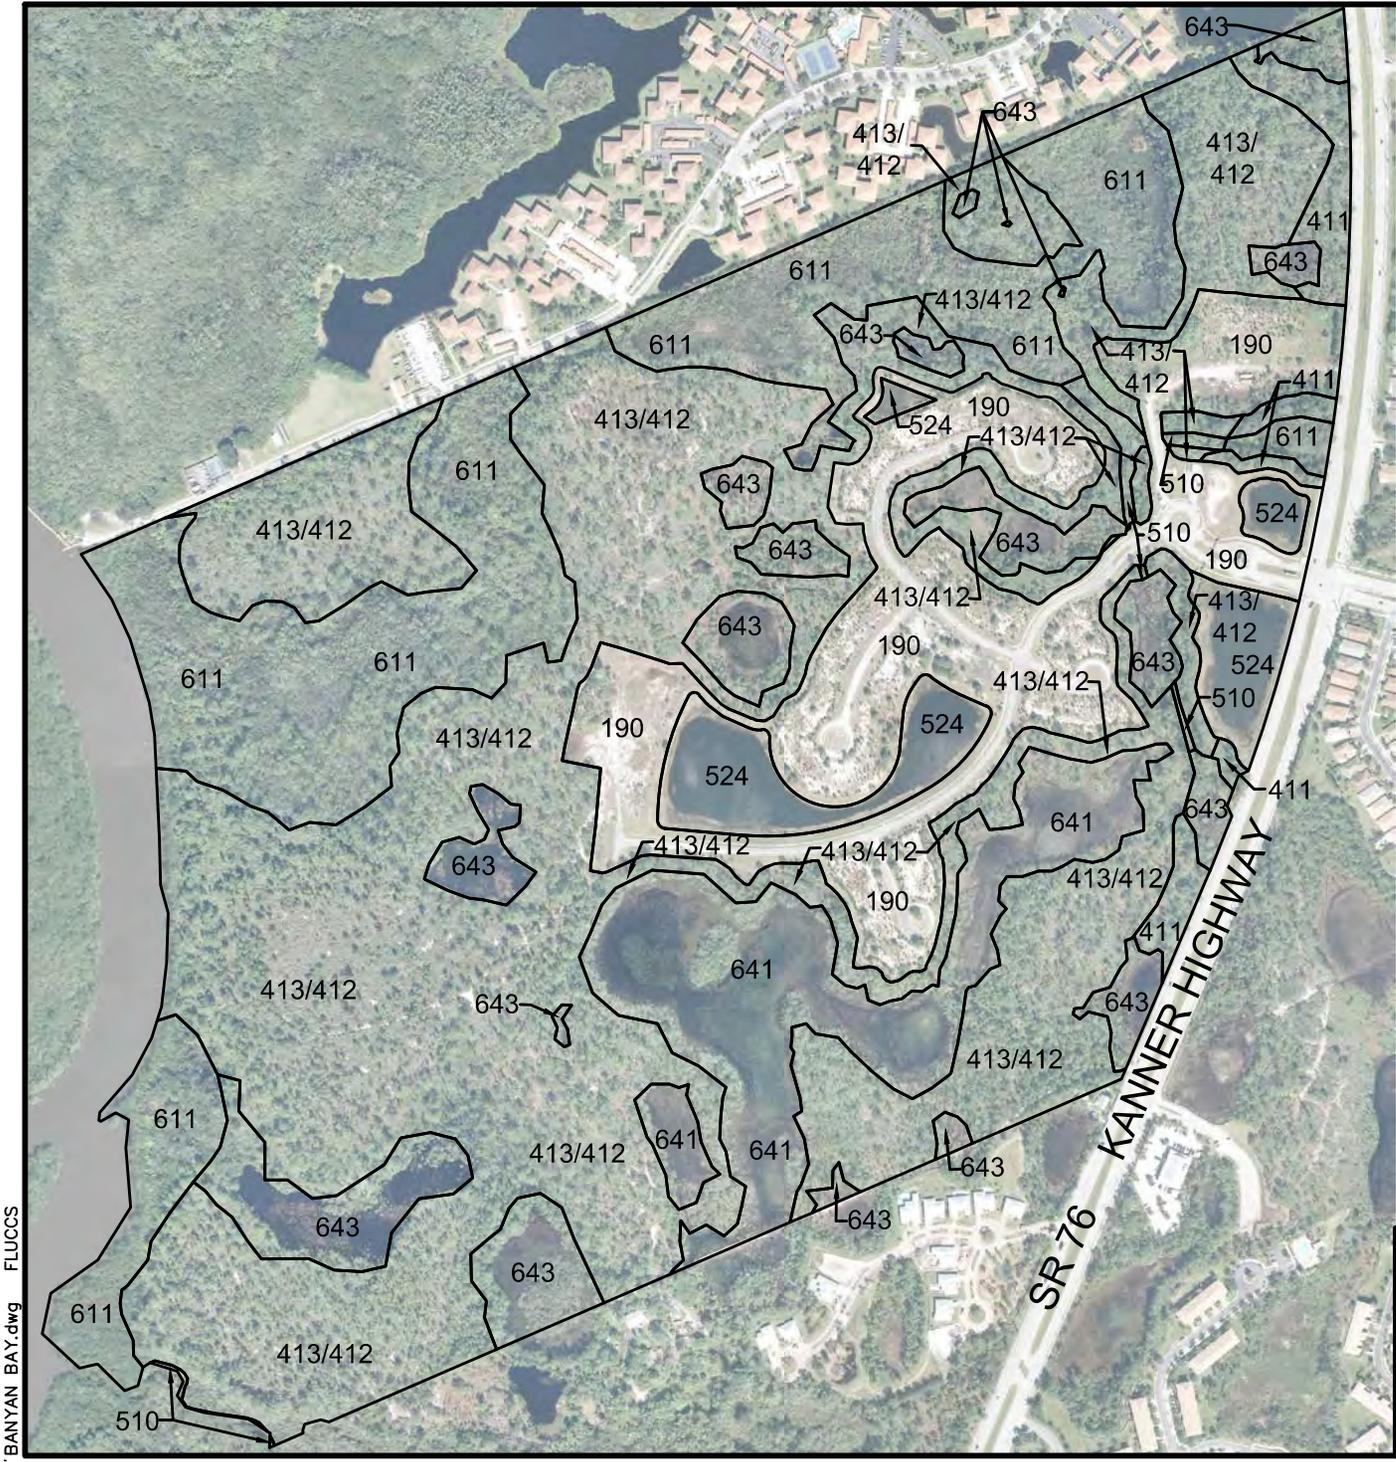
EW CONSULTANTS, INC. <small>1000 SE MONTEREY COMMONS BLVD., SUITE 208 STUART, FL 34996 772-287-8771 FAX 772-287-2988 WWW.EWCONSULTANTS.COM</small>	FEB 2017 FIGURE 4A

- LEGEND**
- 190 - OPEN LANDS
 - 411 - PINE FLATWOODS
 - 413/412 - SAND PINE SCRUB /
SCRUBBY FLATWOODS
 - 510 - DITCHES
 - 611 - BAY SWAMP
 - 641 - FRESHWATER MARSHES
 - 643 - WET PRAIRIE

The site contains native wetland and upland habitats, as well as several previously impacted and/or cleared areas. The following is a summary of the land cover found on the subject site. Land cover classifications are mapped based on the Florida Land Use, Cover and Forms Classification System (FLUCCS) developed by the Florida Department of Transportation. Recent fieldwork and aerial photo interpretation were used in developing the land cover map. A description of each land cover type is below and such areas are shown on Figure 4, FLUCCS Map, in Appendix A.

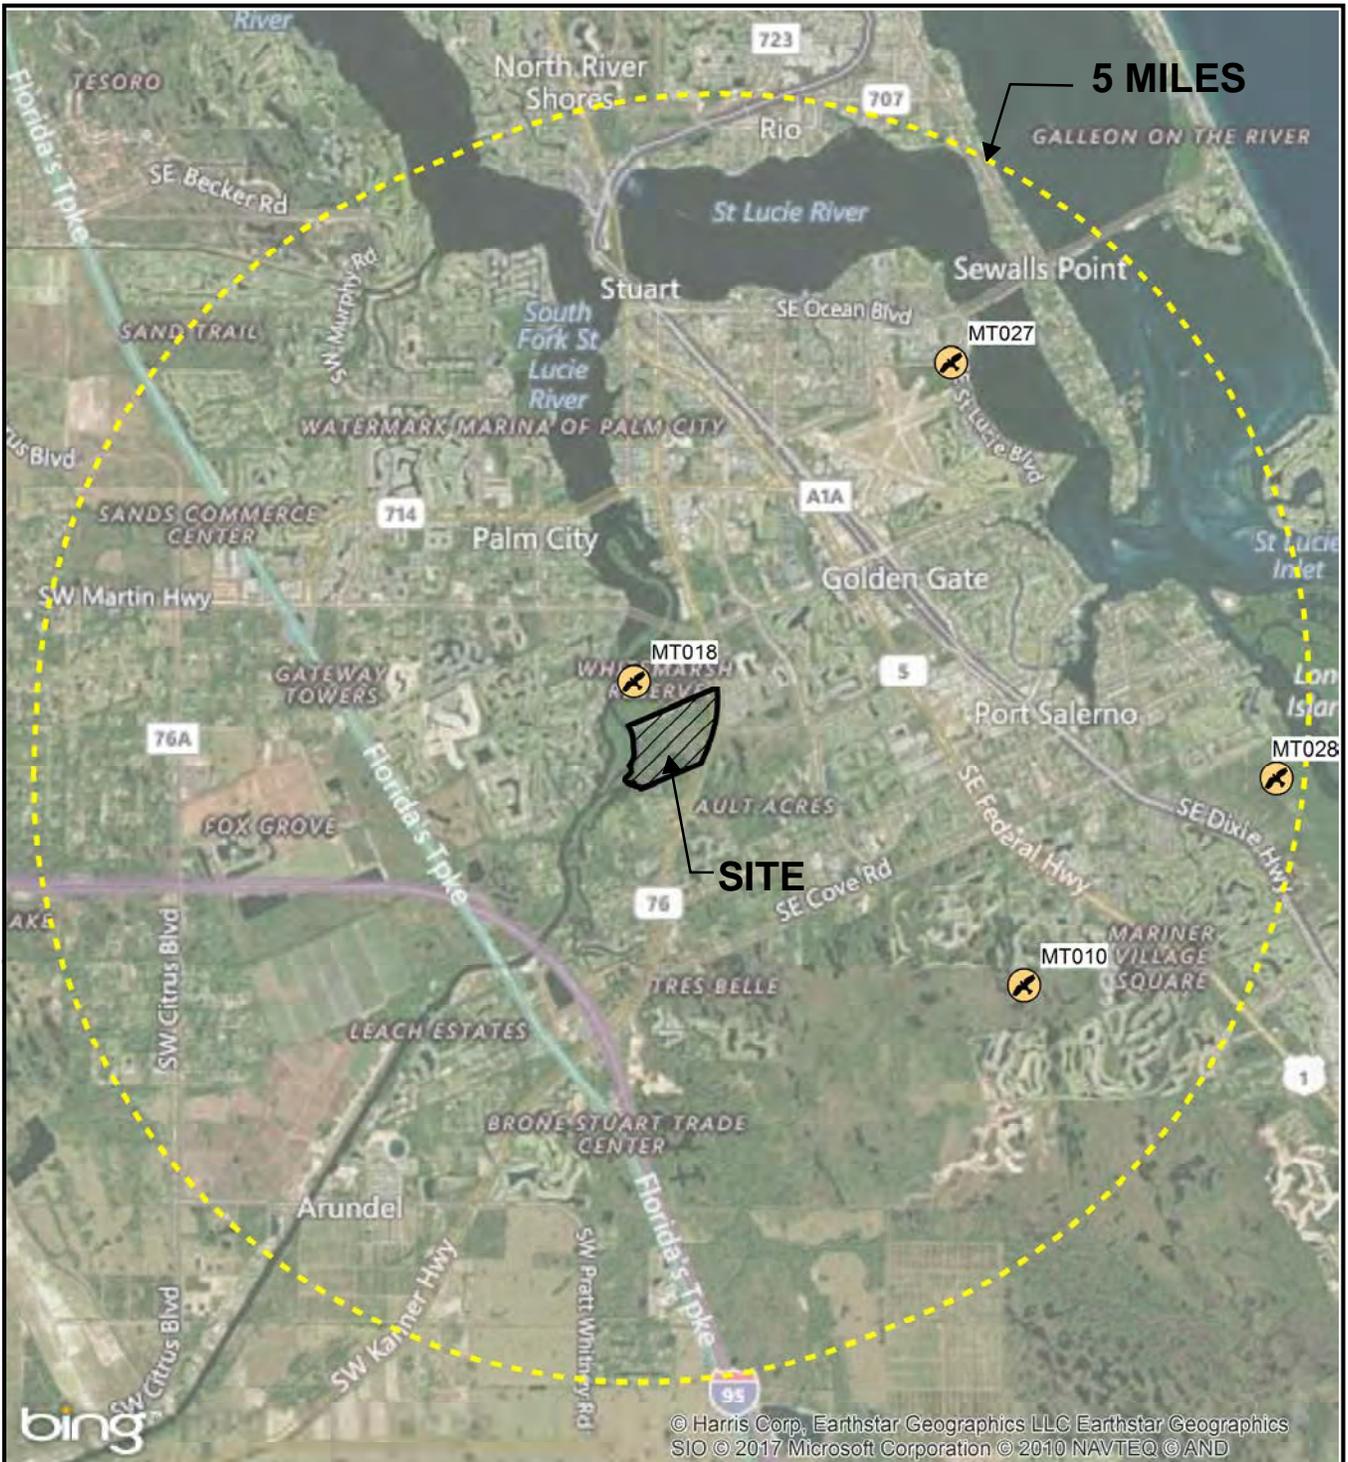
FEB 2017
FIGURE
5

Figure 5: FWC Wading Bird Rookeries

A map showing recorded wading bird rookeries is provided as Figure 5 in Appendix A. Information for this map was obtained from Florida Fish & Wildlife Conservation Commission databases. Since the foraging range of the protected wood stork is considered to be approximately 18.7 miles, the project site, and thus its wetlands and other surface water features, are within the foraging range of numerous identified wading bird rookeries located in the St. Lucie and Indian Rivers, the Savannas State Park, and the DuPuis Reserve/Hungryland/Corbett Wildlife Management Area complex.

The results of database searches of state and federal listed species are included in Figure 5 for wading bird rookeries and Figure 6 for eagle nest locations. The entire limits of the master plan has been permitted for over a decade with the South Florida Water Management District; therefore coordination with state agencies such as Florida State Historic Preservation Office (SHPO) have been completed.
