**AMENDED PRESERVE AREA  
MANAGEMENT PLAN**

**MARTIN COMMERCE PARK PUD**

**Sections 19 and 24/Township 38 South/Range 40 East**

**EW Consultants, Inc.**

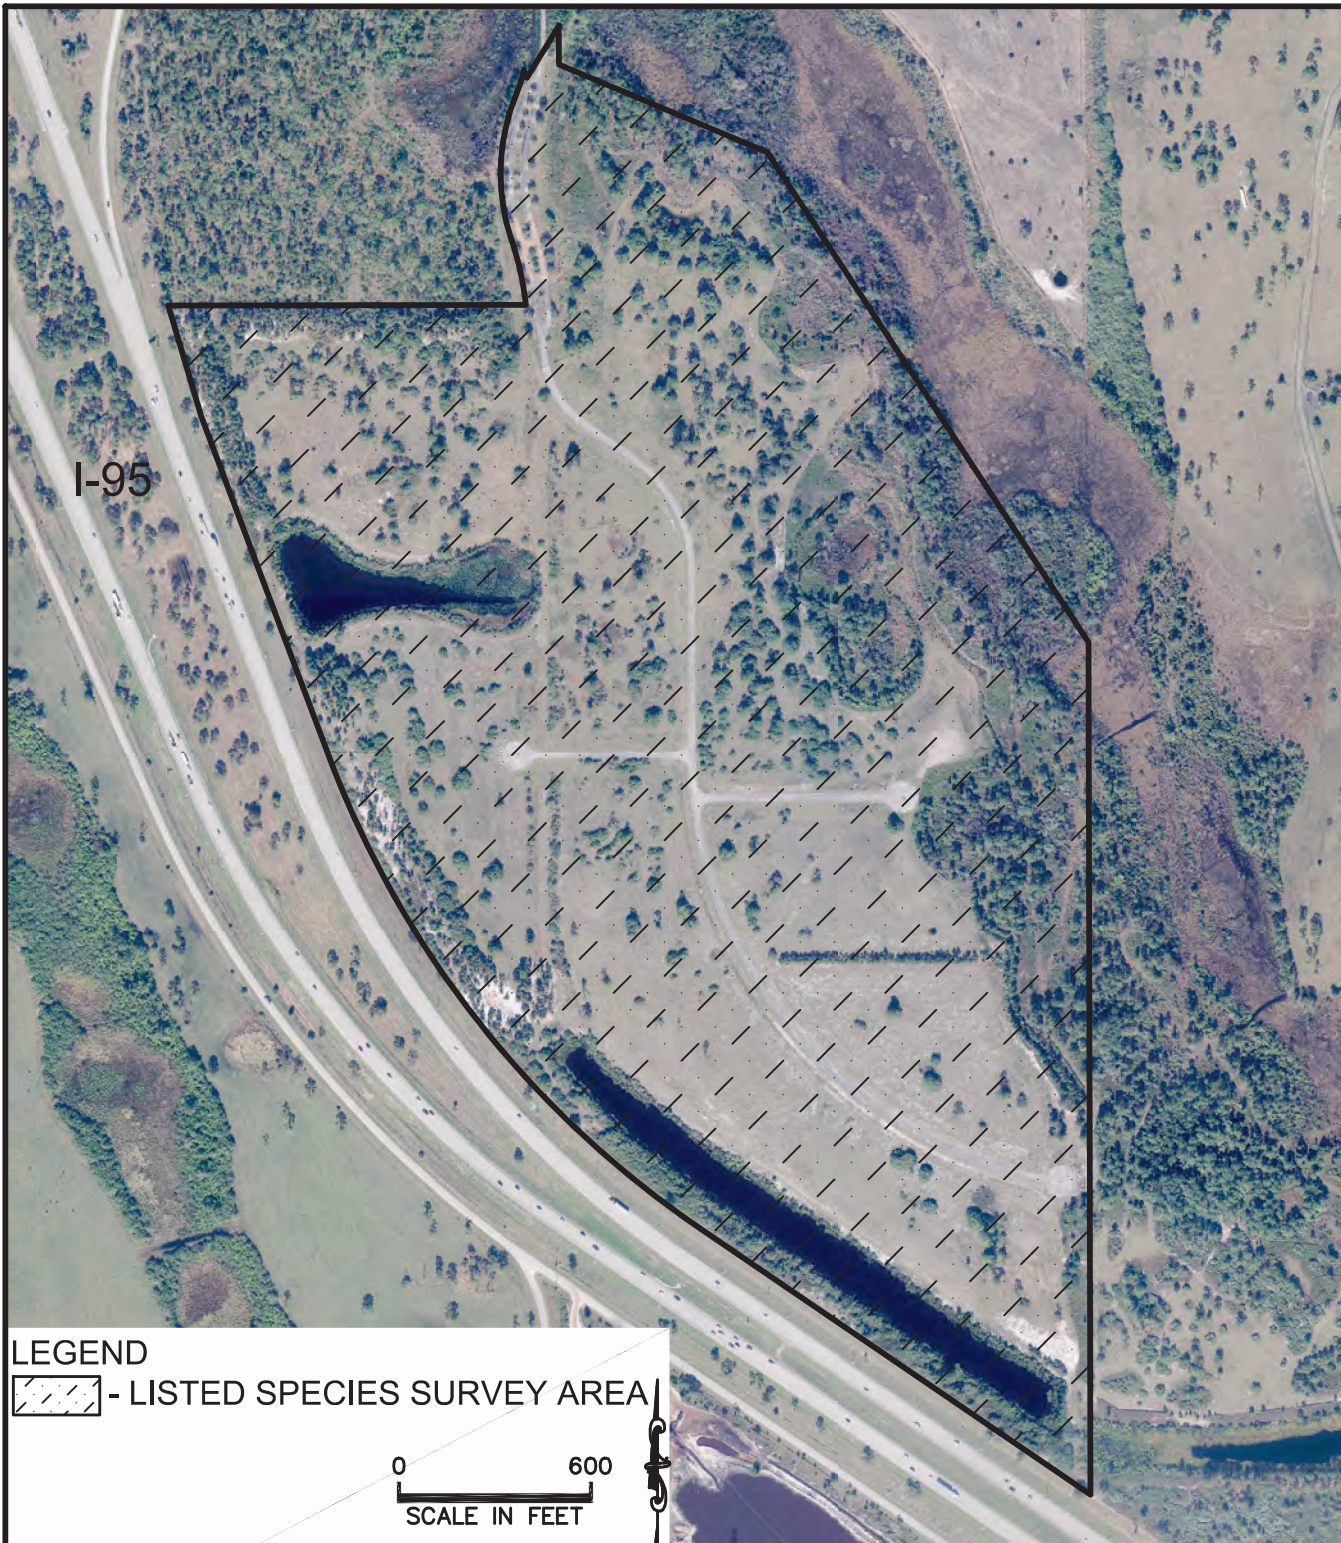
**4**

# **MARTIN COMMERCE PARK PUD** **LISTED SPECIES SURVEY AREA**

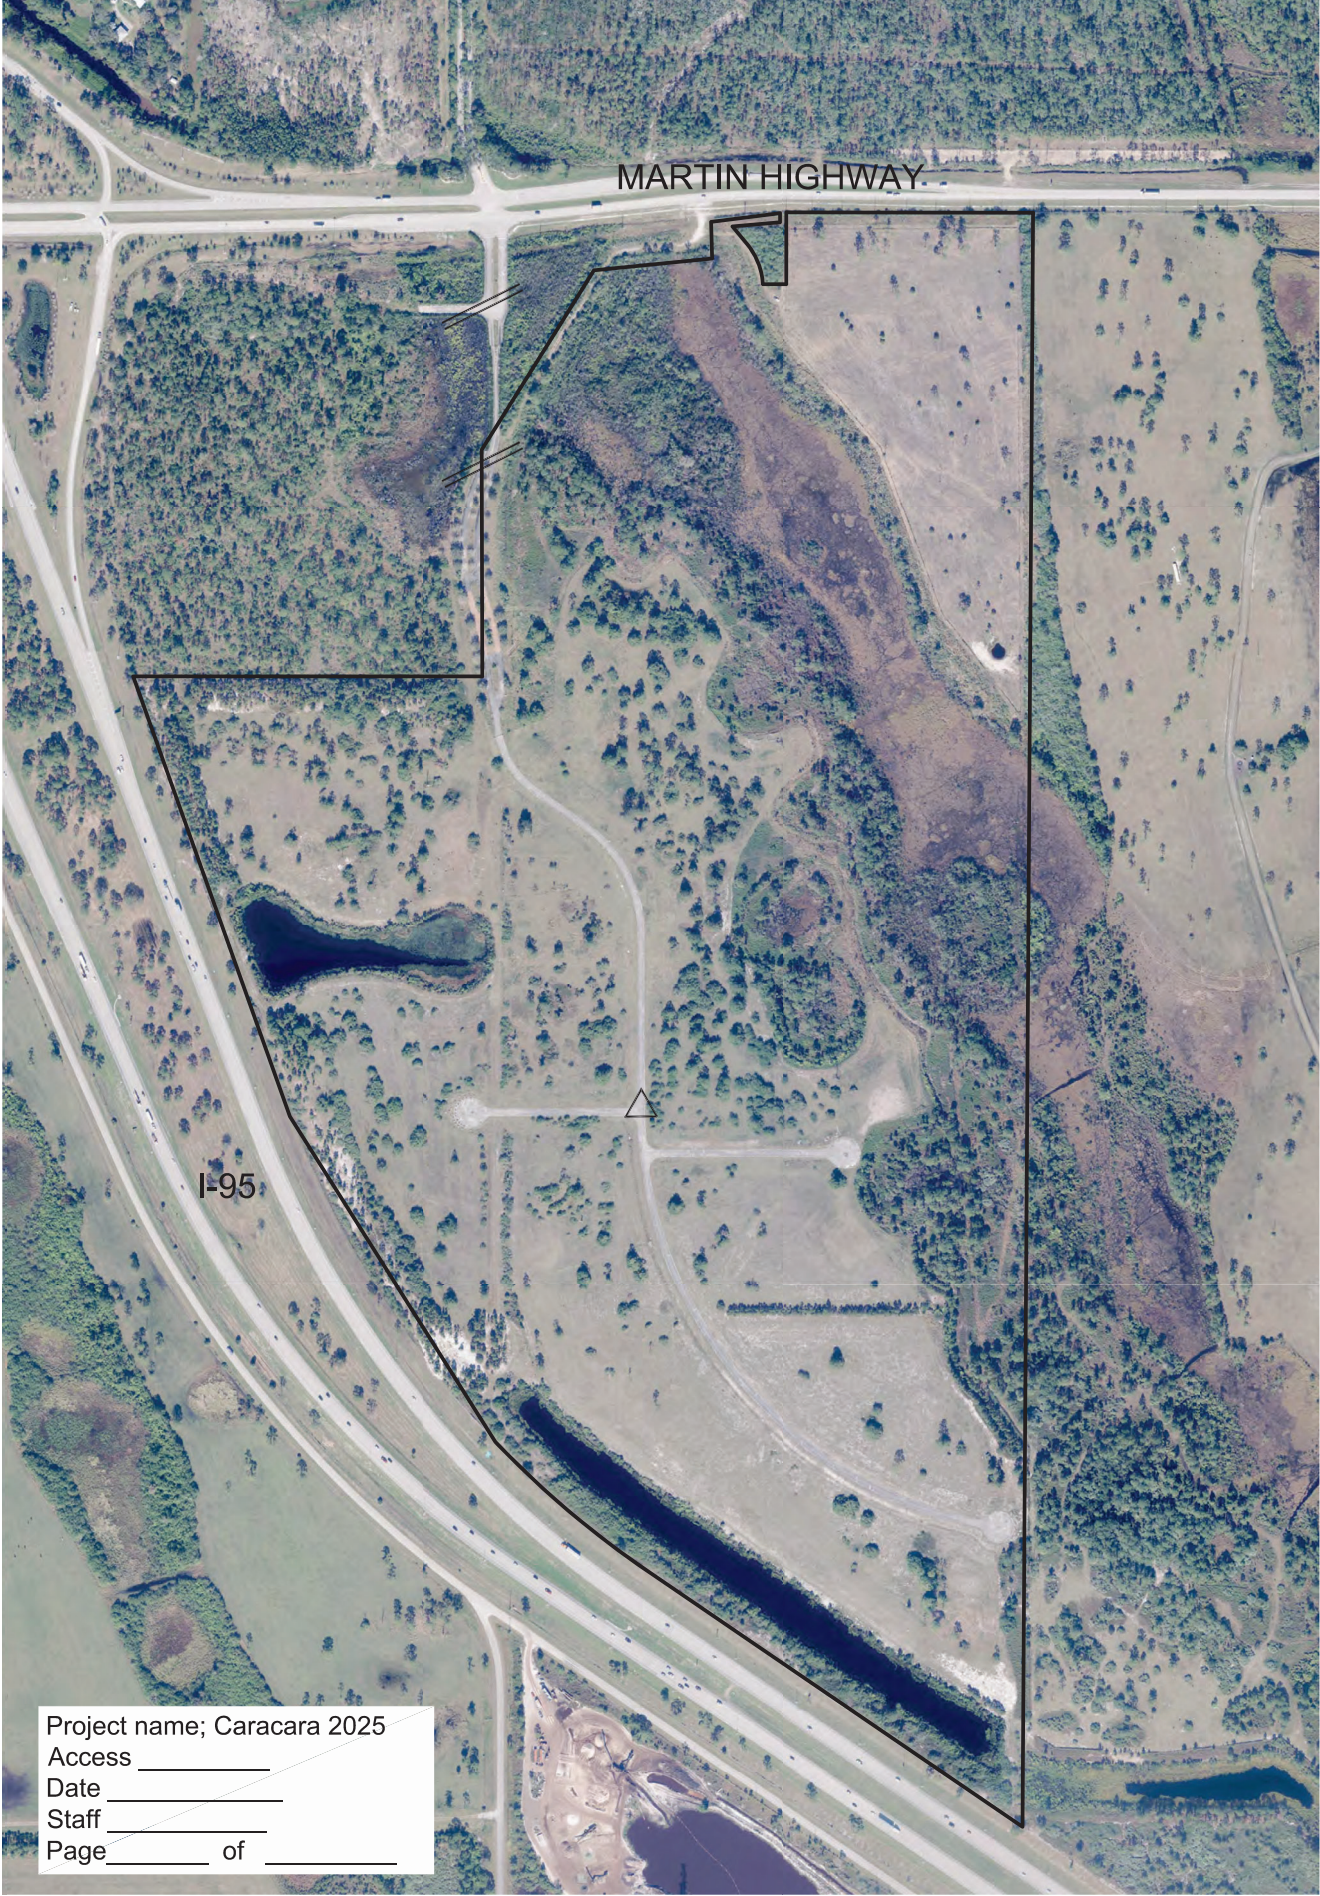
**1**

Project name; Caracara 2025  
Access \_\_\_\_\_  
Date \_\_\_\_\_  
Staff \_\_\_\_\_  
Page \_\_\_\_\_ of \_\_\_\_\_

MARTIN COUNTY AERIAL DATED 2025

The location of the observer for data collection events was selected based on known site conditions. The data collection and observations were conducted from within a parked vehicle for at least three hours for each event. Observations were also made throughout the site, primarily by vehicle, following the initial three-hour stationary data collection event. Observations were conducted along Martin Highway prior to the start of each survey to inspect for the presence of carrion. The field notes from each survey data collection event are provided in the Appendix along with a Monitoring Station Map depicting the location of the observation point.
