PRESERVE AREA MANAGEMENT PLAN MARTIN COUNTY GROWTH MANAGEMENT DEPARTMENT ENVIRONMENTAL DIVISION

The Preserve at Rio Marine Village (±14.34 acres)

PART I ENVIRONMENTAL ASSESSMENT

Environmental Assessment The Preserve at Rio Marine Village

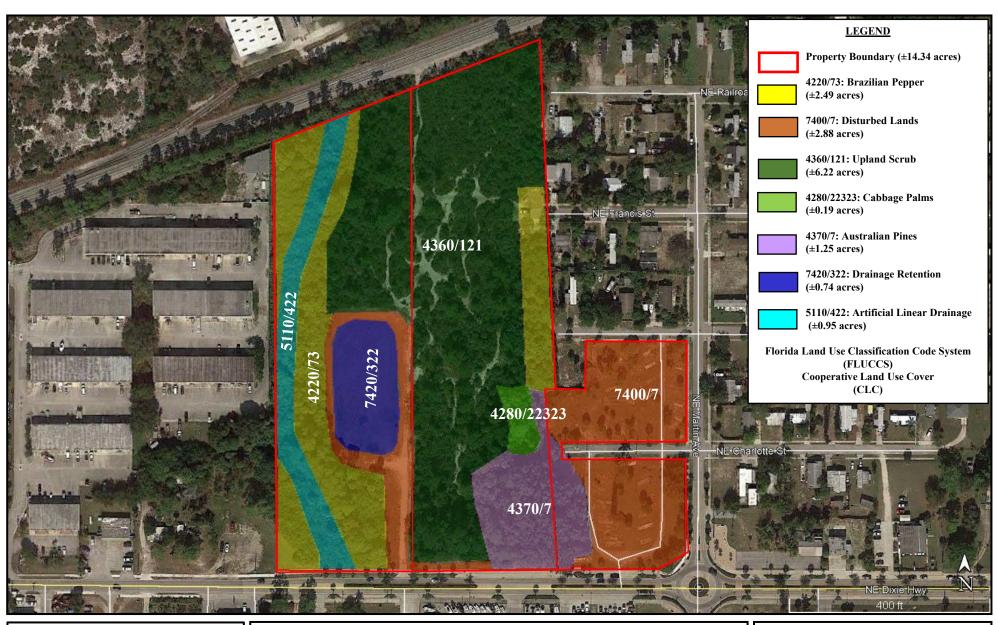
Existing Habitat/FLUCCS Map

Parcel ID Numbers 28-37-41-000-013-00290-9, and 28-37-41-000-014-00300-5 are approximately 85% vegetated. These parcels mainly consist of upland scrub, considered a rare and unique upland habitat type in Martin County. Rare and unique habitats have a priority preservation status. Remaining upland portions of these two (2) parcels consist of a small cabbage palm hammock, Australian pines, Brazilian pepper, and disturbed lands. Additional lands consist of a platted detention area and an artificial linear flow way. No wetlands are present within these two (2) parcels. Please see Appendix A, Figure 4 for habitat locations and approximate sizes.

A drainage/flow way easement is platted over a portion of the property, centrally located but slightly offset towards the west side. An active detention area is the main component of this easement. Additionally, an artificial linear drainageway traverses along the western property edge, observed to be conveying water at the time of site assessment (Appendix A, Figure 4)

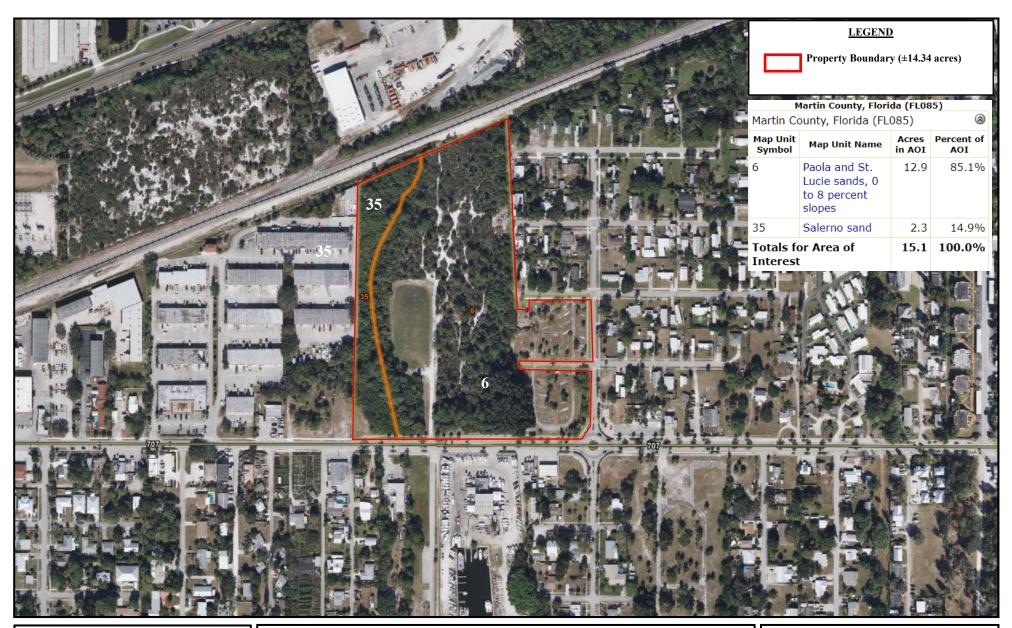
Soil(s) Map

- 35 Salerno Sand- This is a poorly drained, slowly permeable soil. It is formed from marine sediments and found throughout the flatwoods.
- 6 Paola and St. Lucie Sand This is an excessively drained soil formed in sandy marine sediments. Paola soils are found on ridges, hills, and flats.
